# TWO SLIDES THAT DAMAGED PARTS OF A LINING AT BISASAR ROAD LANDFILL, DURBAN

JON PASS and CLIVE WILSON

Wilson & Pass Inc, Consulting Civil Engineers  
Durban, 14 Palm Springs, 155 Ridge Road, Durban

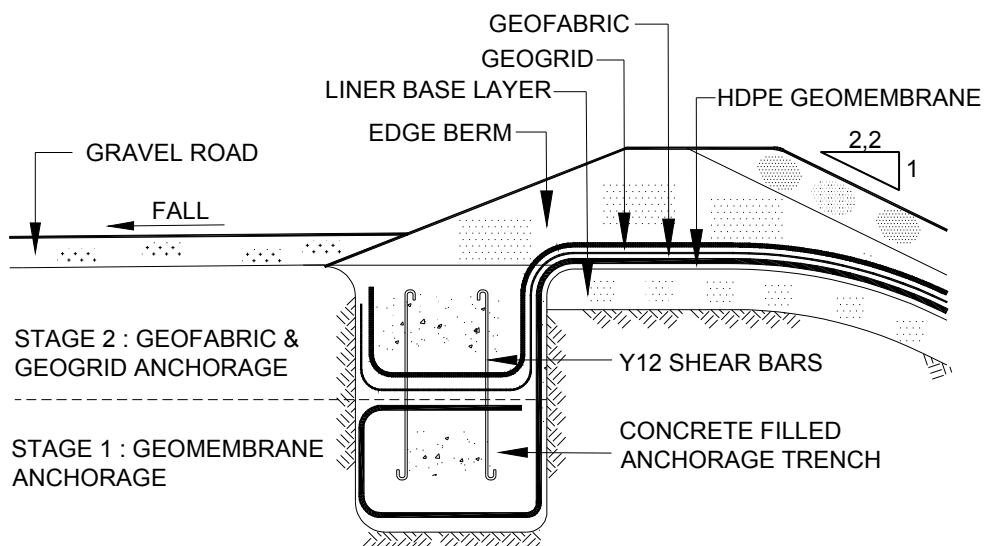
**Figure 3. Bisasar Road Landfill Site Randles 2d : Lining Anchorage System**

Ingress of water under the top edge of the Protection Layer was initially thought to be unlikely, provided the access track was not flooded for a prolonged period. As shown in Figure 3, the Protection Layer was intended to lap over the anchor trench, to prevent direct ingress by rainfall and runoff. In the event, however, this was the route through which water penetrated to cause the slides.

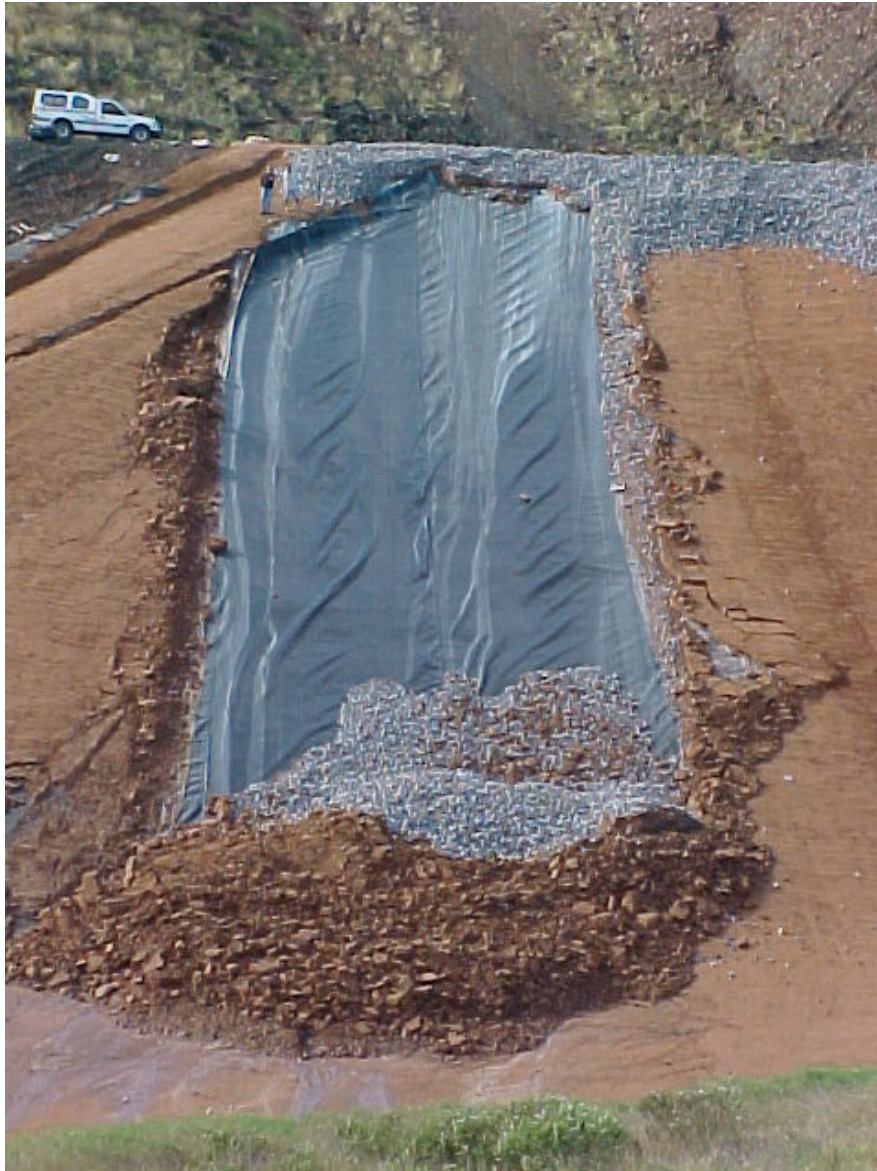
**Figure 4. Bisasar Road Landfill Site Randles 2d : View of Slope after First Slide**

Heavy rain fell on Bisasar on the evening of 24 June 2003 (including 27mm in only 80 minutes). A strip of the Protection Layer, about 14m wide and extending over the whole height of the slope (20m vertically; 55m inclined or slope distance), slid to the bottom, sometime that night. Figure 4 shows a view of the slope the day after the slide. Areas on either side were damaged but remained in place.

The lower part of the strip of the Protection Layer affected by the slide had been placed the day before the slide took place. The cement in the material had not, therefore, yet fully cured. The remains of the soft, uncured, material were evident in the slide debris, as it had deformed in a plastic manner typical of un-cemented, or poorly cemented material. The balance of the debris, derived from the slightly older parts of the layer higher up the slope, which had cured to a greater degree, broke into larger fragments in a more brittle manner.

The Geogrid and Geotextile under the cemented sand Protection Layer both tore away from the anchorage trench at the top of the slope, and also came down.

Examination of the aftermath of the slide indicated streaks over the upper parts of the exposed HDPE Geomembrane, evidently due to flow of water over it, which appeared to have gained entry at the top of the slope, as seen in Figure 4. Inundation of the access track above the slope, due to impeded drainage of runoff, was clearly the source of such water.

Two runoff streams met on the access track above the part of the slope where the First Slide occurred. A drainage channel along that portion of the track had furthermore become blocked.

If water could infiltrate between the Protection Layer and the HDPE Geomembrane more rapidly than it could exit, it would have accumulated in the Geotextile between them, and hydraulic pressure would consequently have developed therein. Such pressure would have eliminated any small frictional resistance to sliding that may have been contributing to stability once such pressure equated to the weight of the Protection Layer (the Drainage Layer had not yet been placed over the affected area).

Such hydraulic pressure would furthermore have saturated the Protection Layer, caused porewater pressures to develop within it, and resulted in seepage up through it, over the lower part of the slope. This would have reduced the resistance of the Protection Layer to compressive thrust (i.e. have softened it), particularly where the cement had yet to cure. This effect should not however have been of great importance by itself, because the layer had evidently been stable when it was placed, before it had developed any compressive strength.

Accumulation of water beneath the Protection Layer would not have ceased when the growing pressure exceeded the weight of that layer. Thereafter, such pressure would have lifted the layer, thus creating an opening between it and the HDPE Geomembrane, and continued thereafter to progressively “inflate” such opening. Such inflation would have greatly magnifying the tension force in the Geogrid, eventually causing it to tear away at the top of the slope, just below the anchor trench, thus precipitating the slide. Such dislocation and sliding would incidentally have allowed drainage and thus relieved the excess hydraulic pressures. While this would have been too late to forestall the slide, it would have halted progressive overstressing of the Geogrid in the adjacent areas.

After both the First and the Second Slides, the affected parts of the lining were reconstructed. The Protection Layer was, however, in these cases, constructed by building up from the bottom of the slope, so that each additional panel was supported from below as it was placed, by material that had already partially cured.

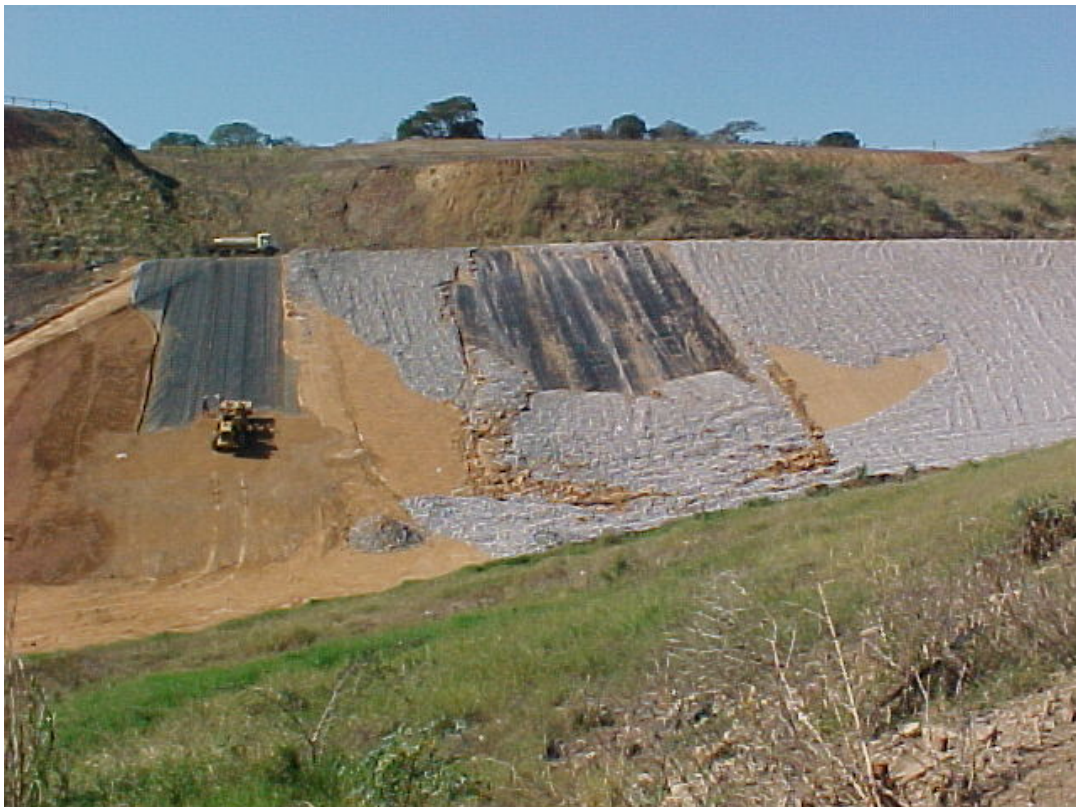
**Figure 5. Bisasar Road Landfill Site Randles 2d : View of Slope after Second Slide**

A Second Slide took place on 12 July 2003, after nearly 3 weeks without rain. A strip of the Protection Layer and Drainage Layer, about 24m wide, and again extending over the whole height of the slope, slid down and came to rest over about the lower third the slope.

The strip affected by the Second Slide was separated from that affected by the First Slide by an intermediate, 15m wide strip, as shown in Figure 5. The intermediate strip remained in place, but was severely cracked.

Stone was being placed for the Drainage Layer over the area affected by the Second Slide at the time it occurred. Almost the entire strip had been covered with such stone when the slide occurred. Stone covered only about 50% of the adjacent strip, however, which became cracked but remained in place.

The Second Slide took place nearly 3 weeks after the First Slide, while stone was being placed on the affected area for the Drainage Layer. As shown in Figure 5, stone had been placed over most of the area affected by the Second Slide (on the left of the photograph).

Placement of stone for the Drainage Layer would more than double the in-plane, downslope force that had to be resisted to prevent sliding. As the capability of Protection Layer, aided by Geogrid, to support the Drainage Layer had already been proven over most of the cell, their capability to do so in the area affected by the Second Slide had evidently been compromised.

The water that caused the First Slide by infiltrating under the Protection Layer could not have been confined beneath just the strip affected by that slide. It must therefore have been present under a wider area, including under the area later affected by the Second Slide. Consequent damage, in the form of tension and compression cracks, were indeed observed in the adjacent parts of the Protection Layer that remained on the slope after the First Slide, including in the area subsequently affected by the Second Slide, although it was not appreciated, at the time, that this had seriously reduced the strength of the overall system.

The cause of the Second Slide was therefore damage to the Protection Layer induced during the First Slide, by the mechanism that caused that slide, which thus precluded it from performing its function of supporting the Drainage Layer when it was placed.

- (a) Stone-filled pockets through the Protection Layer over the lower part of the slope, through which any water that might infiltrate beneath it could drain.
- (b) 400mm wide, concrete ribs, cast in slots formed in the Protection Layer over the lower part of the slope, to increase total resistance to thrust in the plane of the layer.

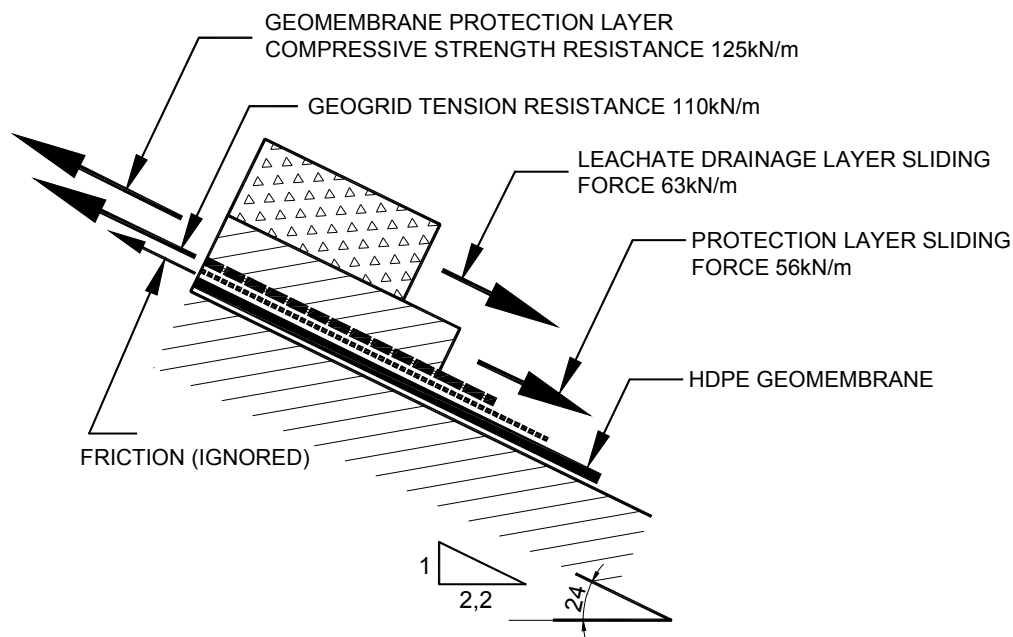
**Figure 6. Bisasar Road Landfill Site Randles 2d : Forces in Liner System**

Support of the cemented sand Protection Layer, to prevent it sliding down the slope, would require a force in the plane of the layer, directed up the slope, equal to 56 kN per metre horizontally, computed as illustrated in Figure 6. The corresponding total force necessary to subsequently support both the Protection Layer and the Drainage Layer together would amount to 119 kN/m.

Tension developed in the Geogrid, plus compressive thrust developed simultaneously in the Protection Layer, could provide such in-plane supporting forces. As the rated tensile strength of the Geogrid was specified to be 110kN/m, it could support the Protection Layer by itself, as indeed it had to do, until the cemented sand cured sufficiently to develop compressive resistance. Thereafter, the Protection Layer would provide most of the necessary resistance in compression to support the weight of the Drainage Layer.
